# Characterizing, optimising, and repairing electrically conductive joints in EV battery applications

# EMPIRE, COMMIT, CODELAB and CABEL

- Improve joint properties, develop fatigue test method, standardise defect acceptance levels, and repair of busbar/tab joints
- Funding: Formas, Vinnova, Energimyndigheten
- Project duration
  - EMPIRE: 2021-2023
  - COMMIT: 2023-2025
  - CODELAB: 2025-2027
  - CABEL: 2025-2026

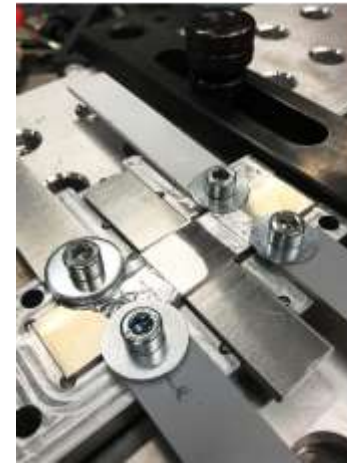
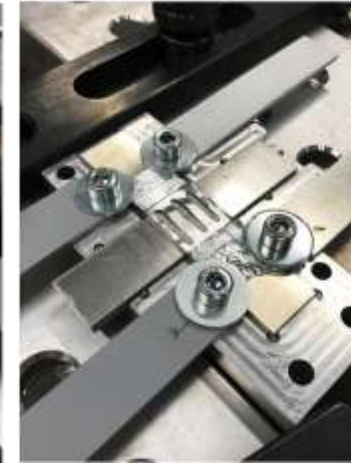
Sample	Aluminium alloy	Size
Lower strip	3003	114 x 24 x 3.2 mm
Upper strip	6101	114 x 24 x 1.2 mm
Filler foil	Al-Si alloy w/ built-in flux	160 micrometre thick foil

Laser-welded with three different laser powers

- 1) Adding a filler material will shift the composition away from the crack-susceptible regime
- 2) Built-in flux will clean the faying surface of oxides and reduce porosity

One foil with an intermediate laser power reduces the frequency of solidification cracks and reduced porosity

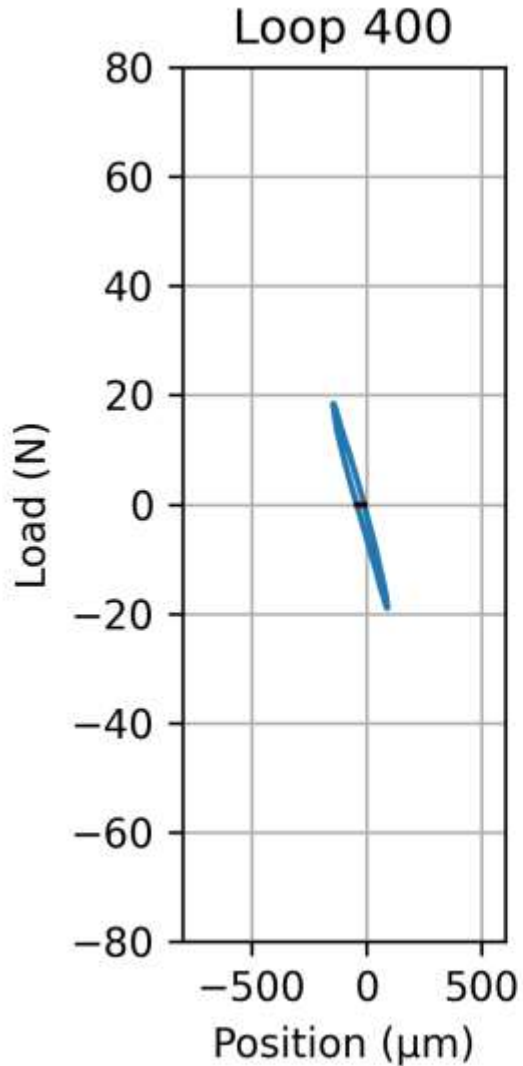
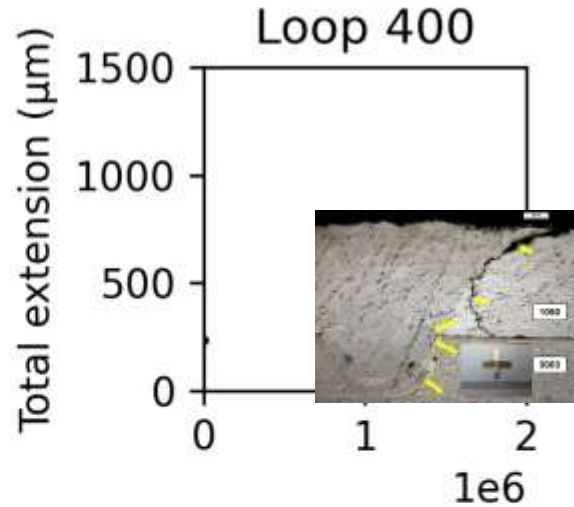
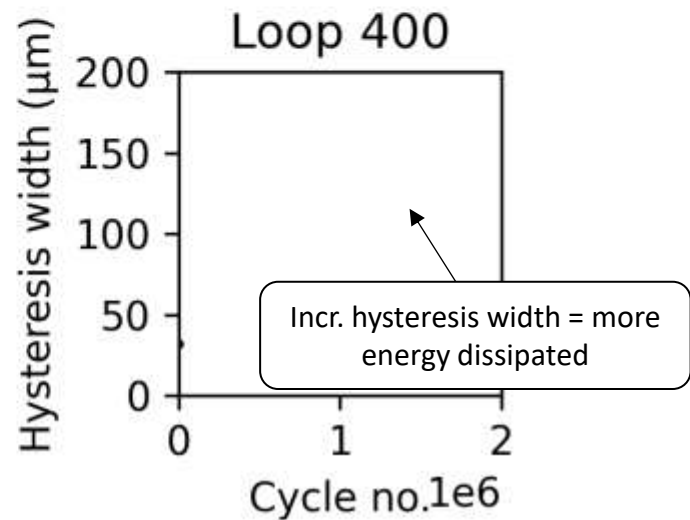
# Fatigue damage was identified via force vs. displacement curves and voltage drop

**Force vs. displacement loop:**  
asymmetry, increasing total extension and hysteresis width

**Voltage drop:**  
Increasing magnitude

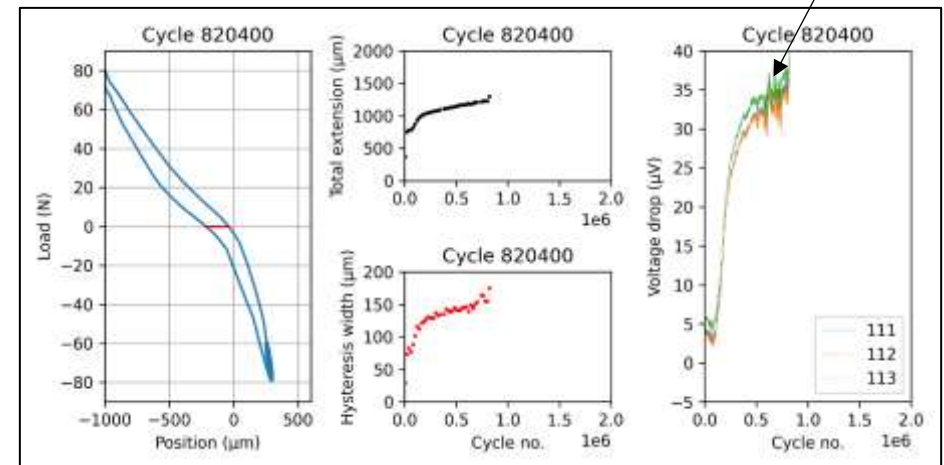
Less current-bearing area from fatigue damage = incr. voltage drop

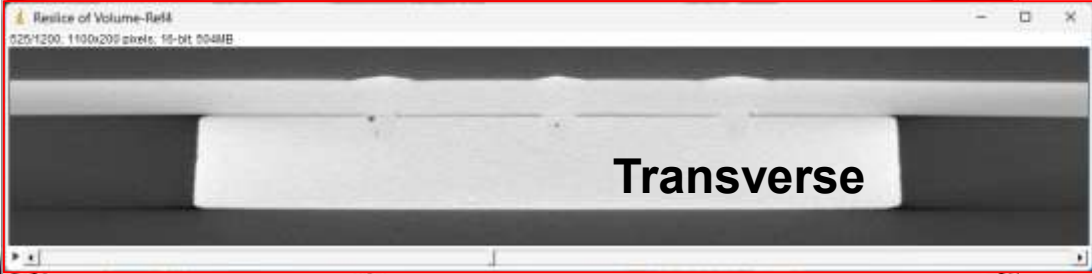
Ref. (as-received)

The heavily oxidized sample possessed more/larger pores in the weld toe

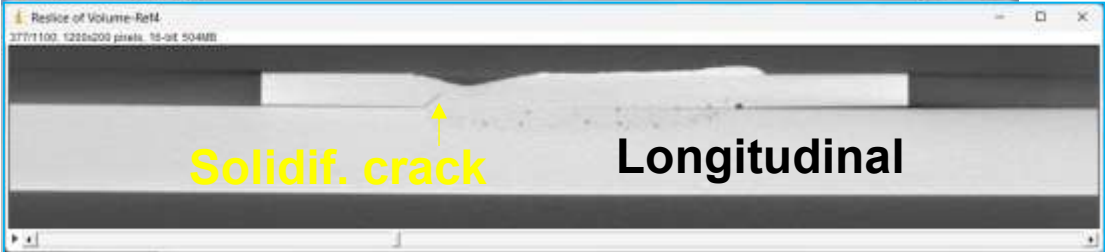
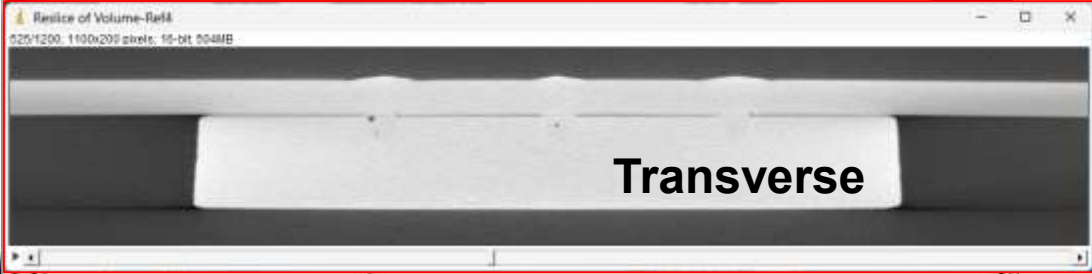
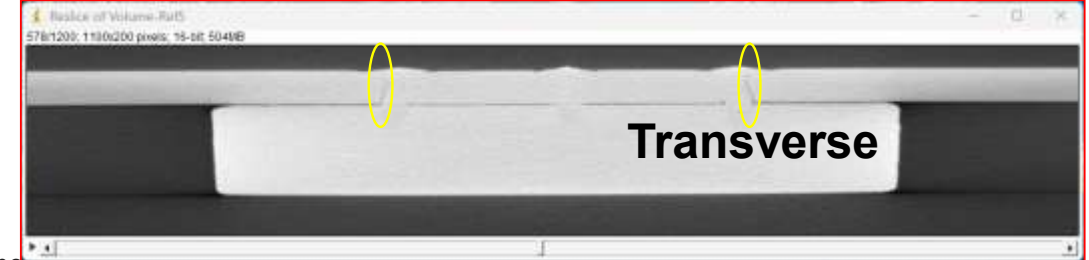
Ref. (fatigued, 50 N,  $2 \times 10^6$  cycles)

# Fatigue cracks initiate at existing solidification cracks in the weld end crater

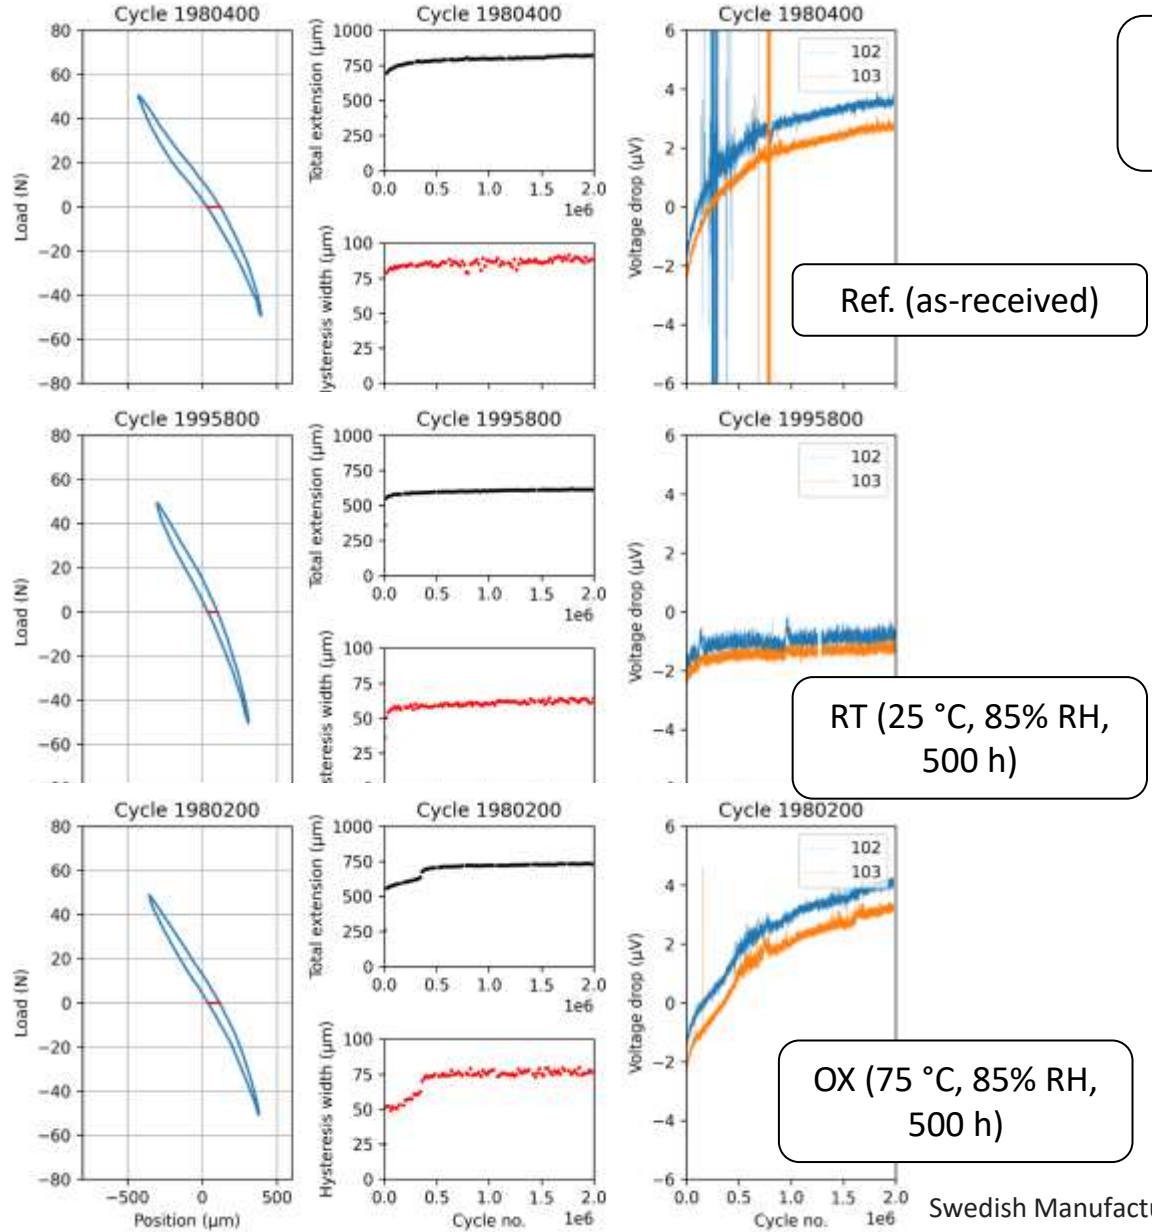
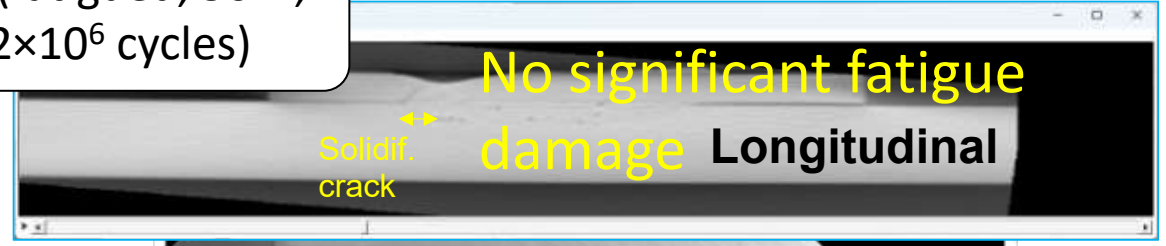
RT (fatigued, 50 N,  $2 \times 10^6$  cycles)

Despite effect on size of pores, no trend of oxidation vs. fatigue performance could be determined

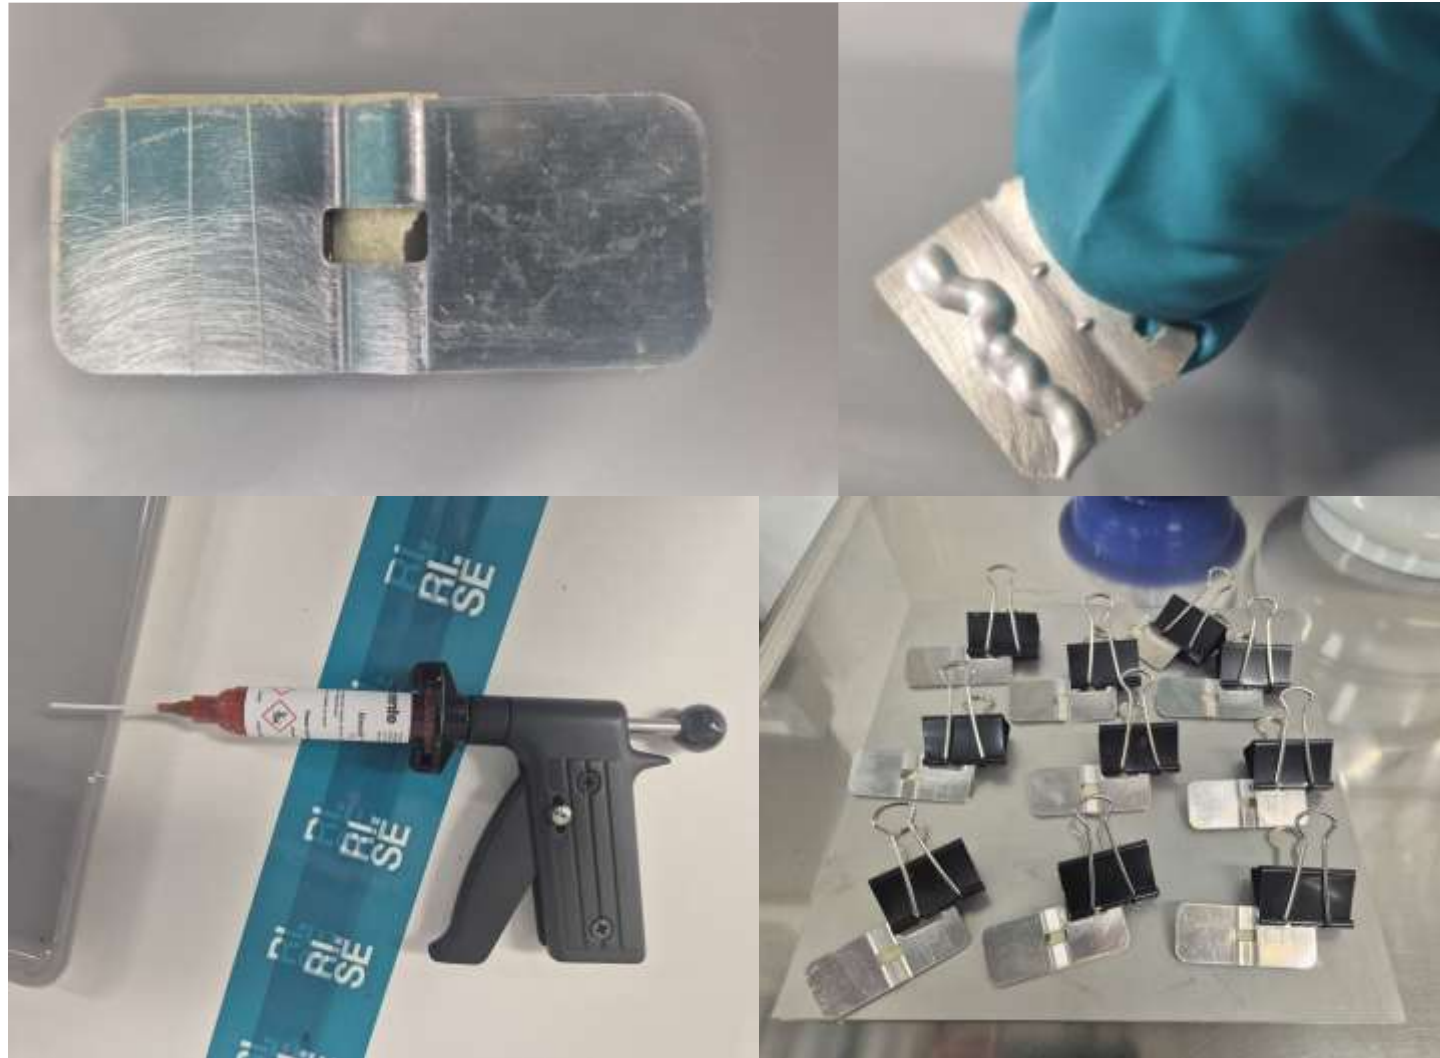
- Silved filled (80 w% Ag) epoxy based adhesive.
- Nickel and aluminium surface pre-treatment.
- Curing at elevated temperature.
- High variations of resistance.
- Best samples comparable to resistance of welds shortly after curing ( $\sim 0.9 \text{ m}\Omega$ )

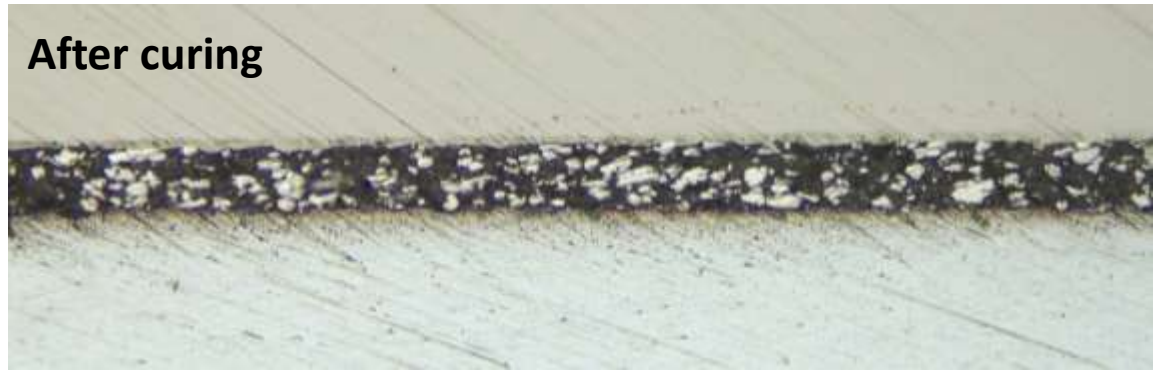
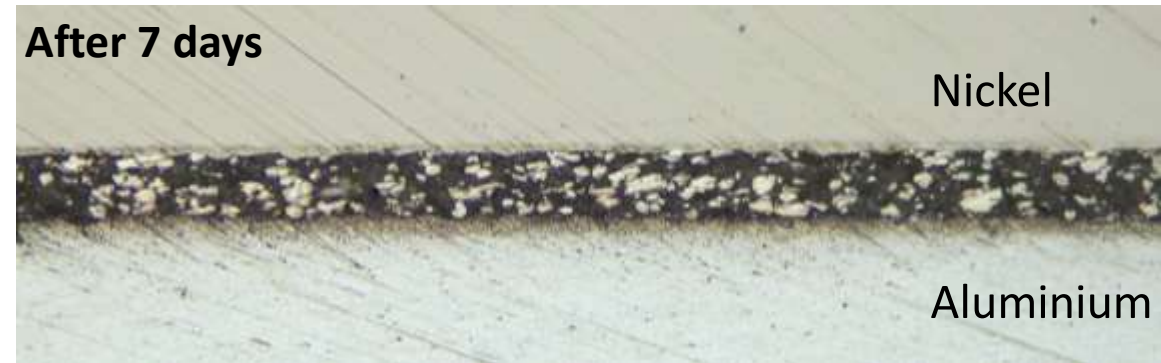
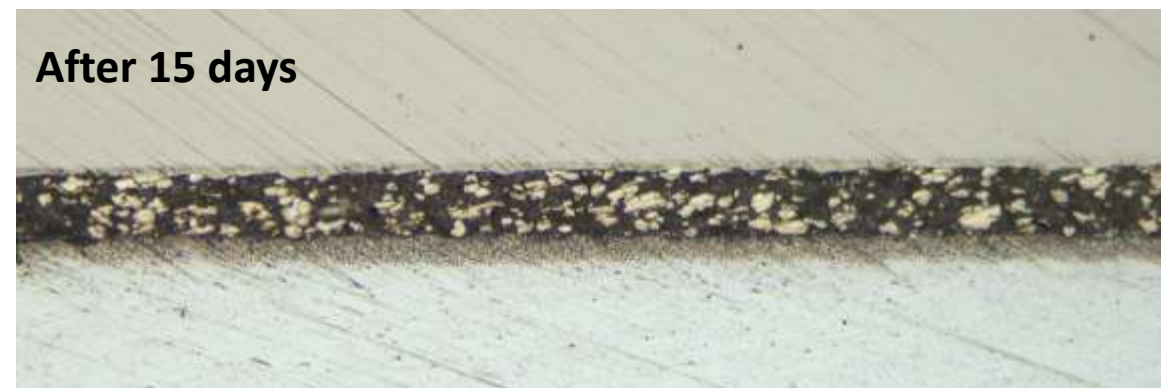
Microscopy of cross-sections done directly after curing, after 7 days and after 15 days.

Shows change at interface between adhesive and aluminium substrate.

Potential growth of oxides or hydroxides.

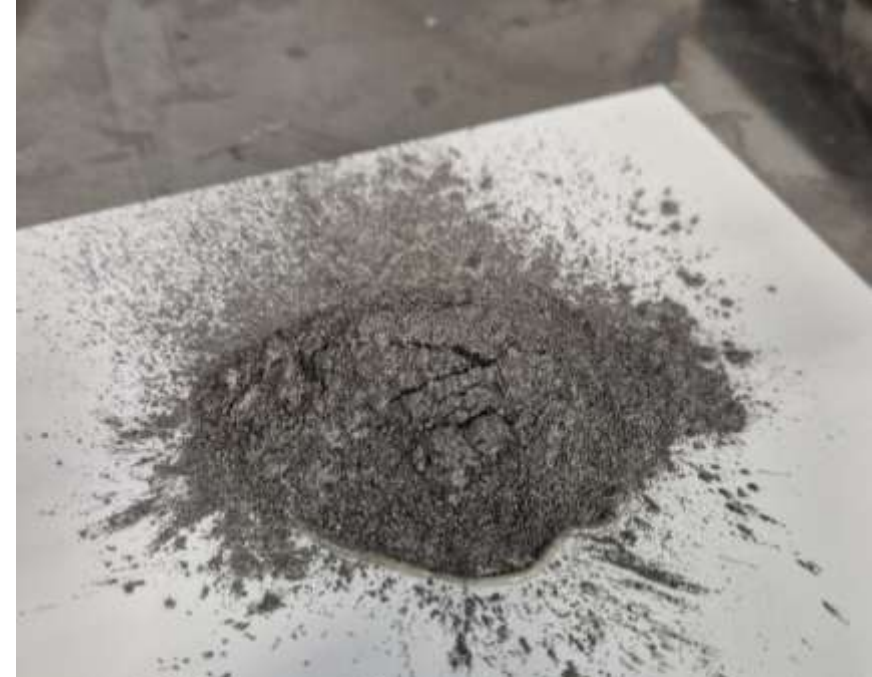
Nickel flakes (~57 w%) and epoxy resin were mixed at RISE lab.

Initial result show promising resistance values of ~1.5 m $\Omega$ .

After 7 days the resistance was nearly unchanged.
